**Building Envelope
Problems**

OPTIMIZE
Envelope Engineering Ltd.

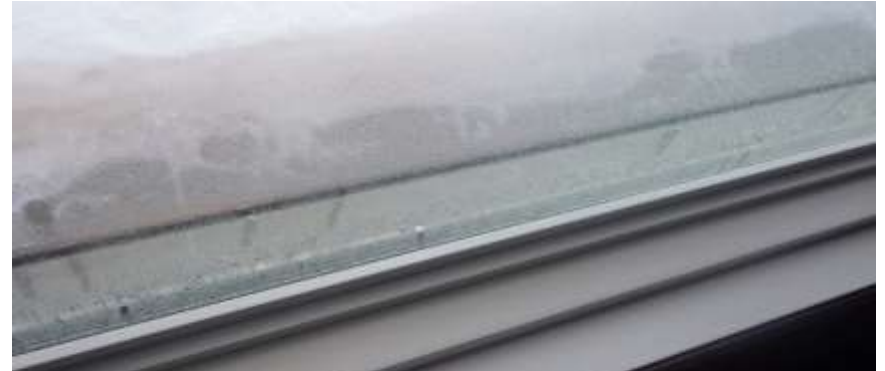
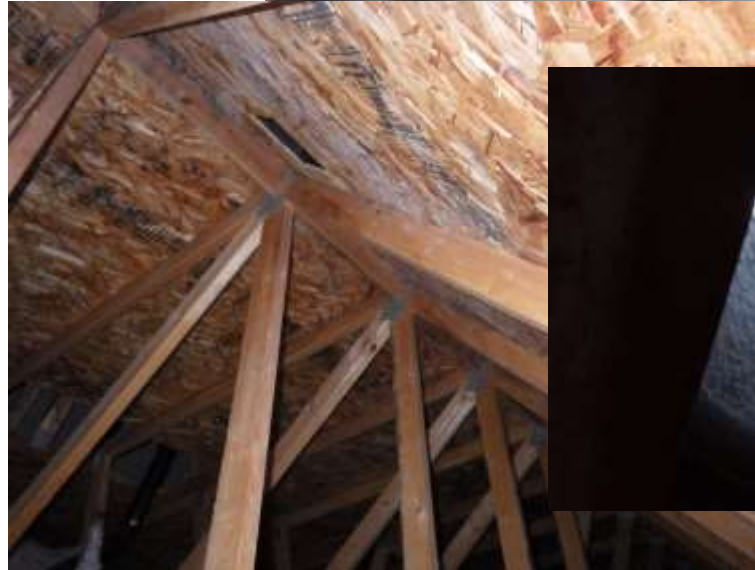
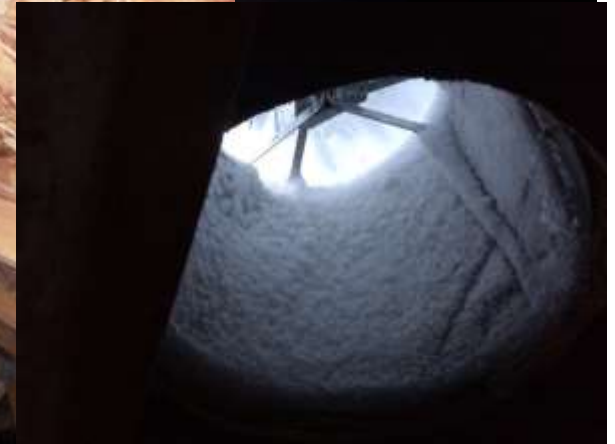
- “Water that collects as droplets on a cold surface when humid air is in contact with it”
- Most common locations
 - Attic/ceiling
 - Bathrooms
 - Windows/doors

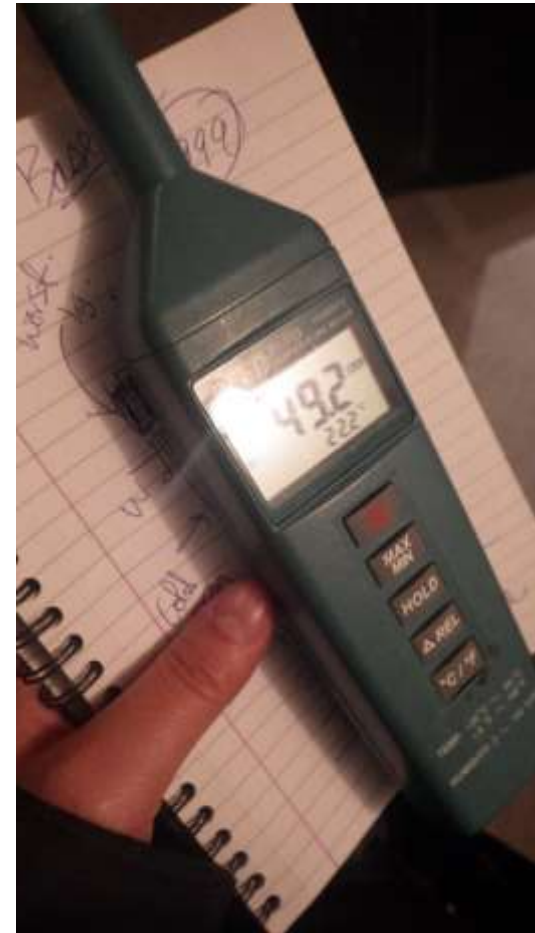
- Humidity too high
- Inadequate ventilation/airflow
- Inadequate air/vapour control

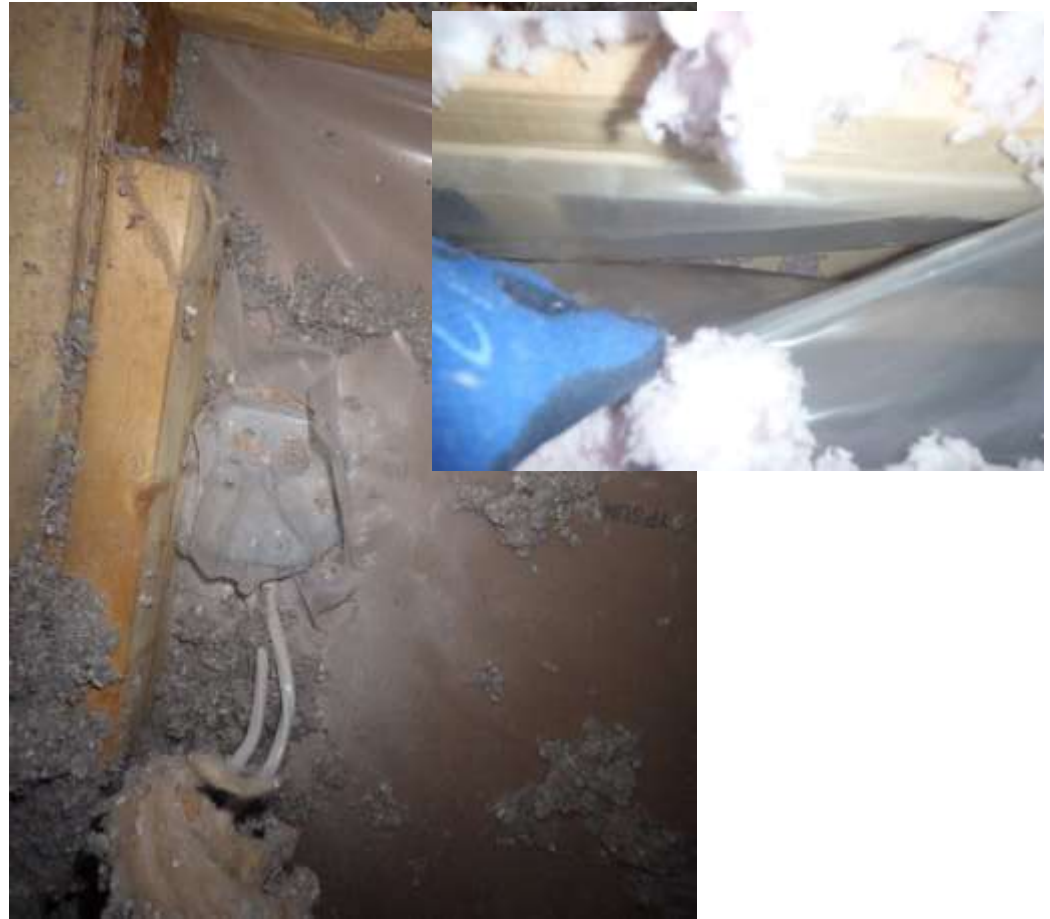
- SOLUTIONS
- Complicated designs
- Why unvented more popular

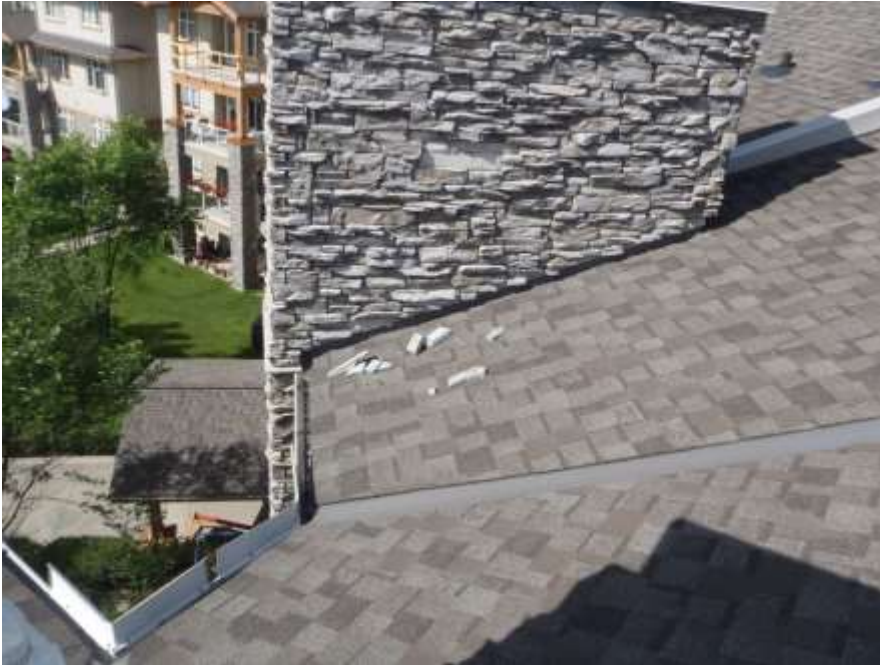
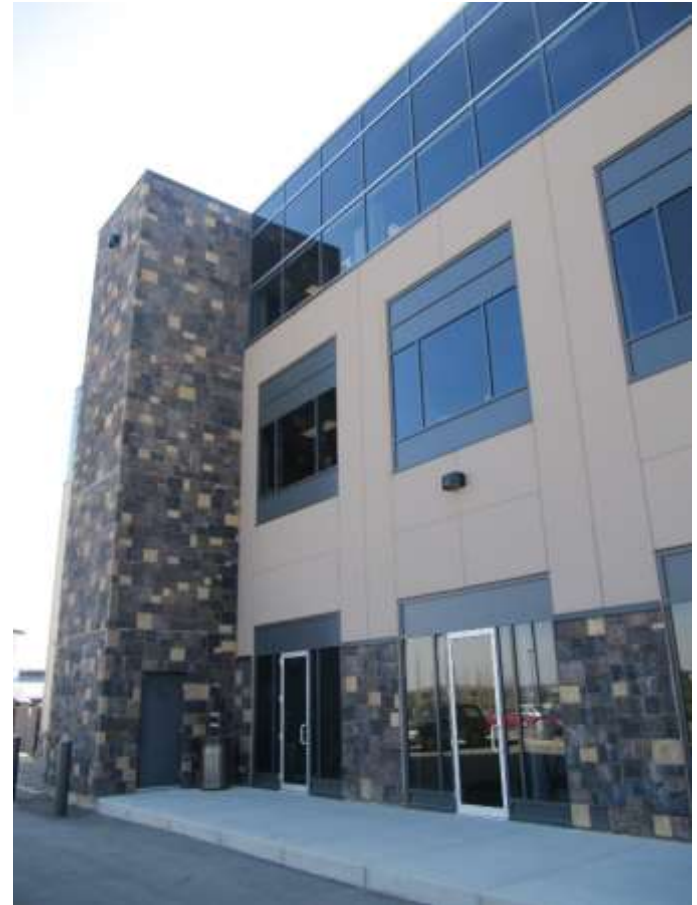
- Falling off
- Used in high applications

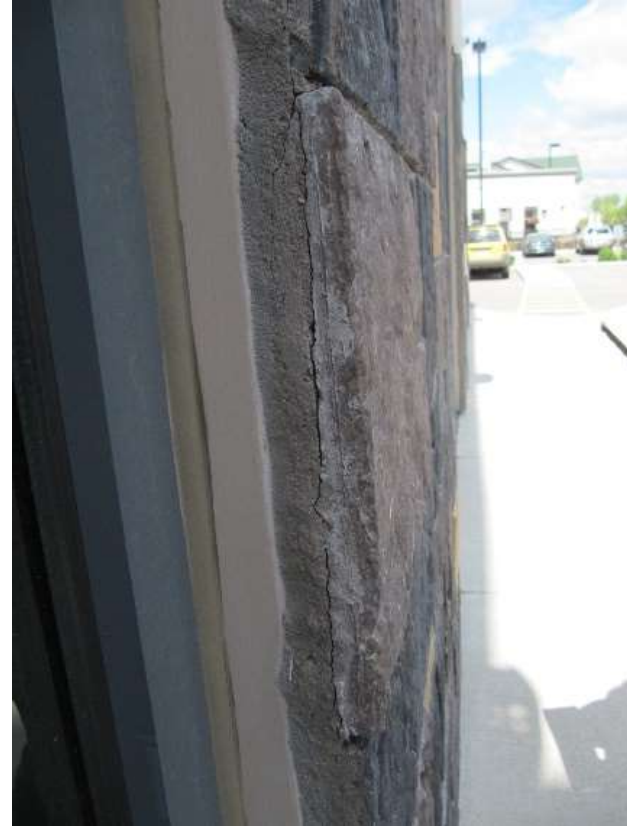
- Bonds failing for variety of reasons
- Some form of installation error
 - Curing temps/time
 - Wrong product, may need bonding agent
 - Inadequate application of product to back of stone

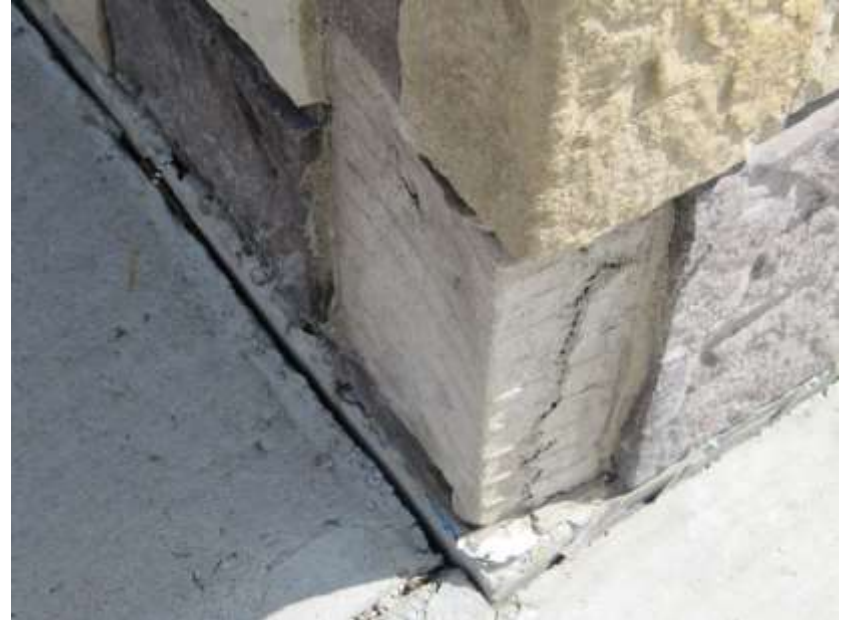
- Improper use of product or lack of protection
- Not necessarily builder/installation issue, but could be a design issue
- Could lead to other compromised areas
- Still may be warranty item

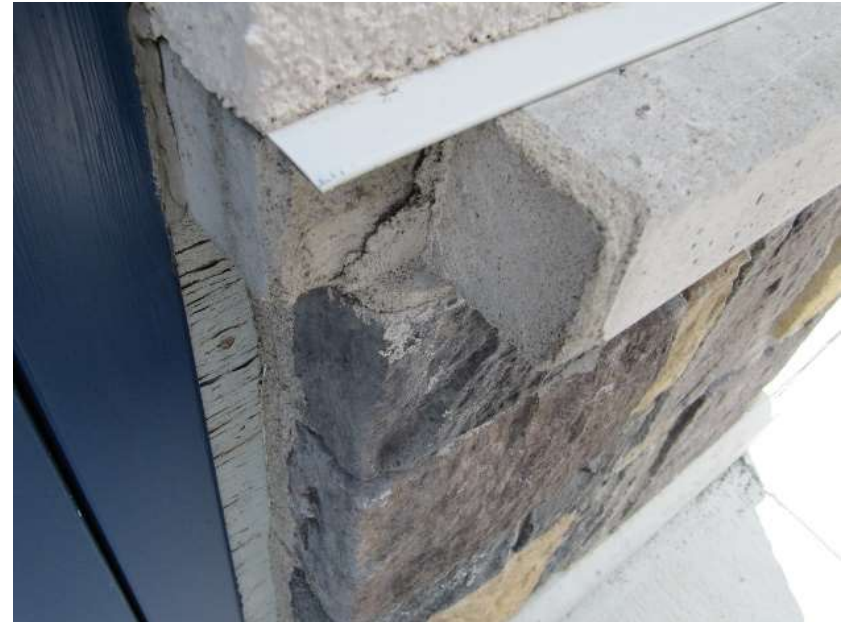
- Unsupported sill stones common
- Walk up and pull them right off
- Often at hip height
- In patio areas in contact with people and/or children
- High risk of failure
- Mortar joints unprotected
- Need support underneath

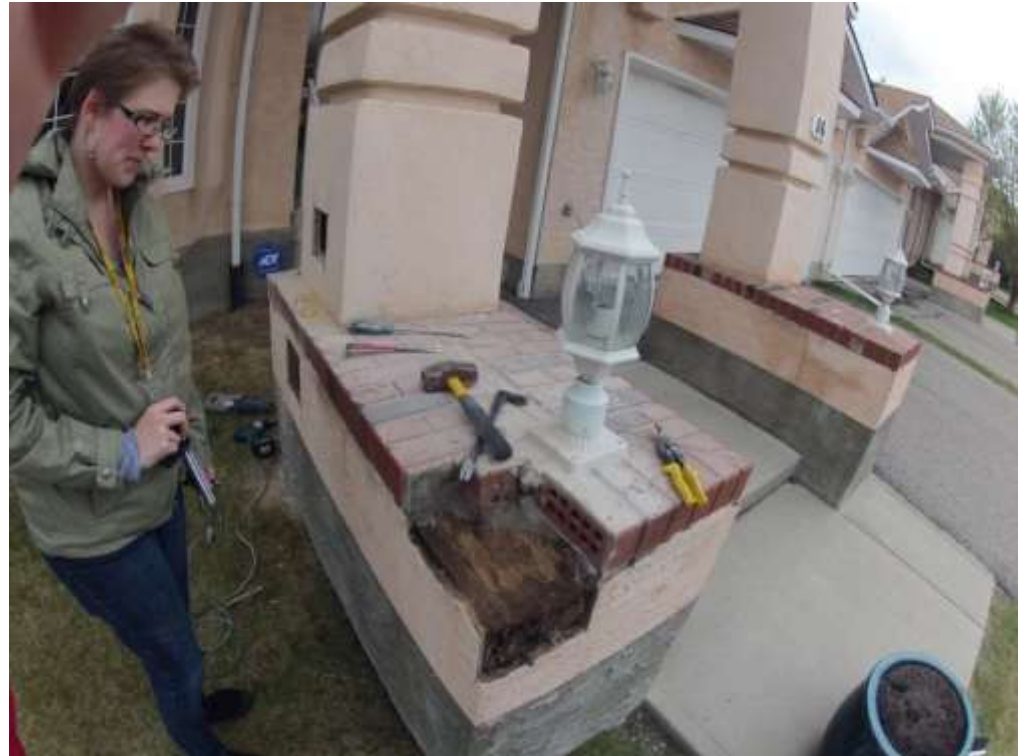
- Exterior columns
- Not technically part of envelope but need protection unless all P.T.
- Seen severe damage and costly repairs
- Require membranes on horizontal surfaces
- Involved in several litigations with poor column detailing involving stone tie-ins

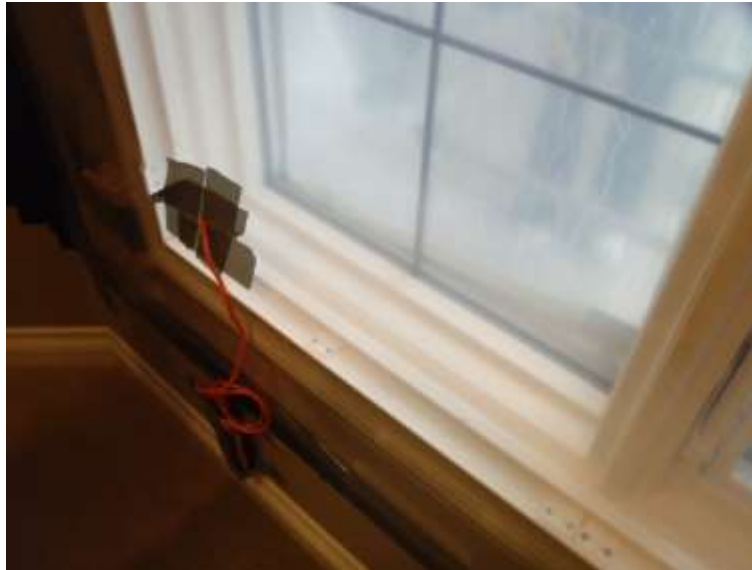
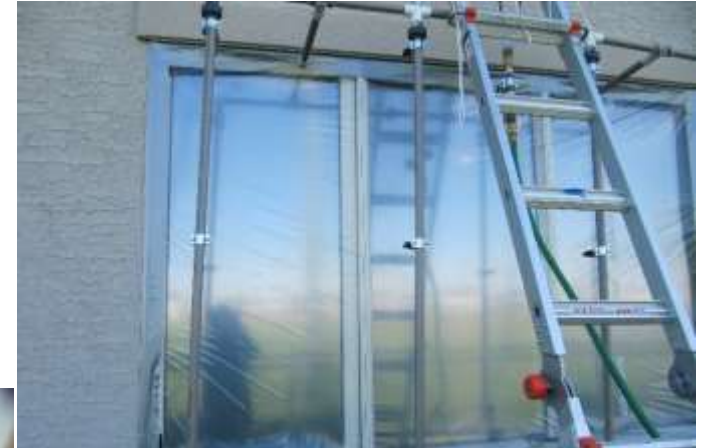
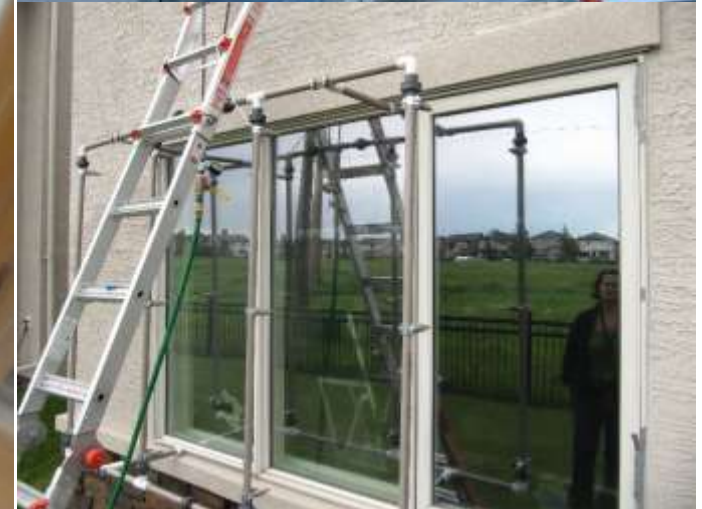
- Simple hose test first
- More complex spray rack
- Isolate window and perimeter

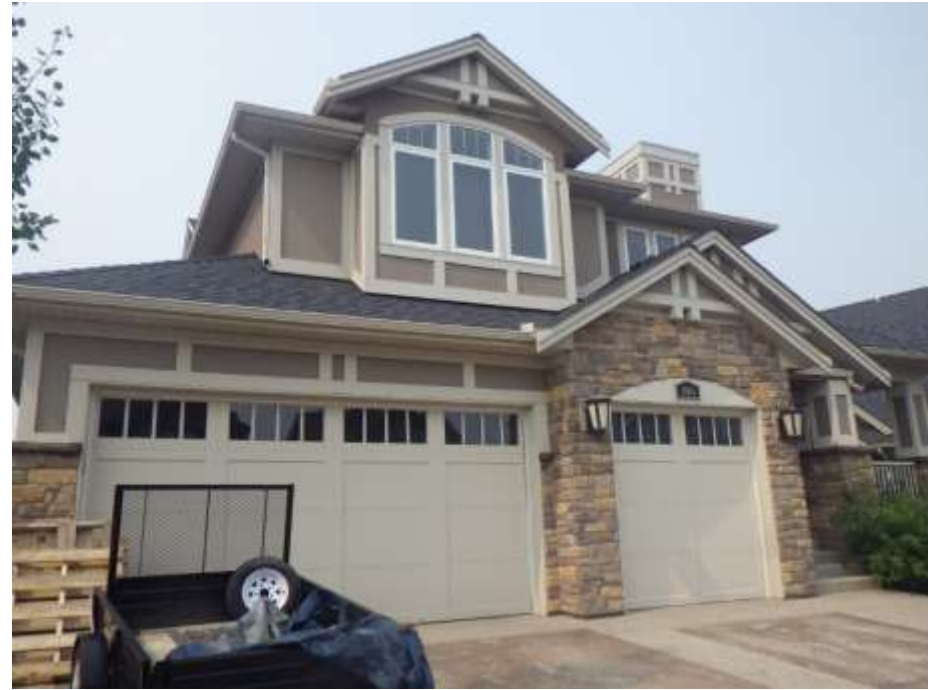
- Typical suburban home
- Builder installed peel and stick membrane under windows
- First rainfall after moving in, homeowner noticed wet carpet under back windows in deck area

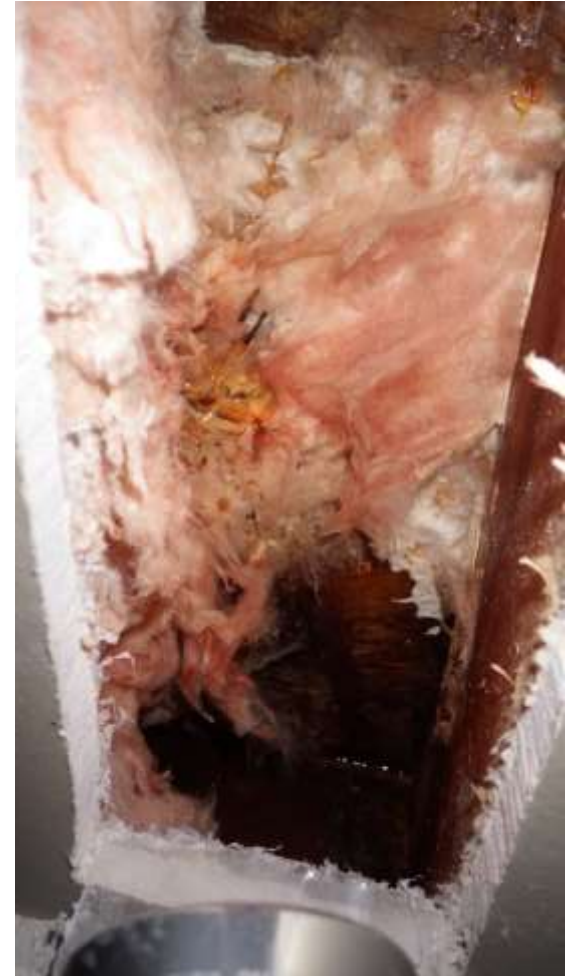
- Drywall opened
- Water test, window was ok
- Window taped off, and area under window spray, water poured in

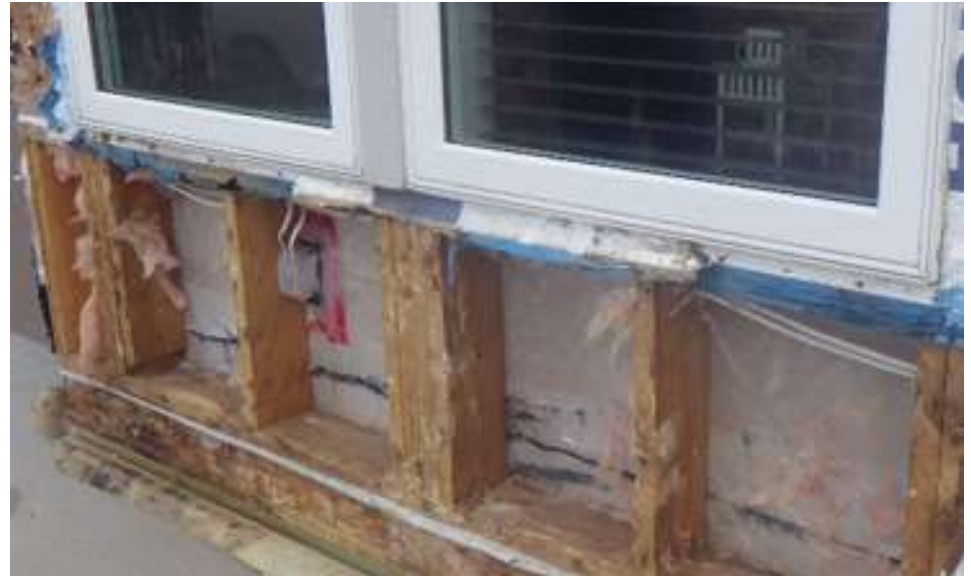
- Mason thought window needed to be sealed
- Covered bottom flanged and put housewrap over membrane
- Water pour in between bottom of window and bottom flashing, behind moisture barrier, behind deck membrane
- Caught before too much structural damage

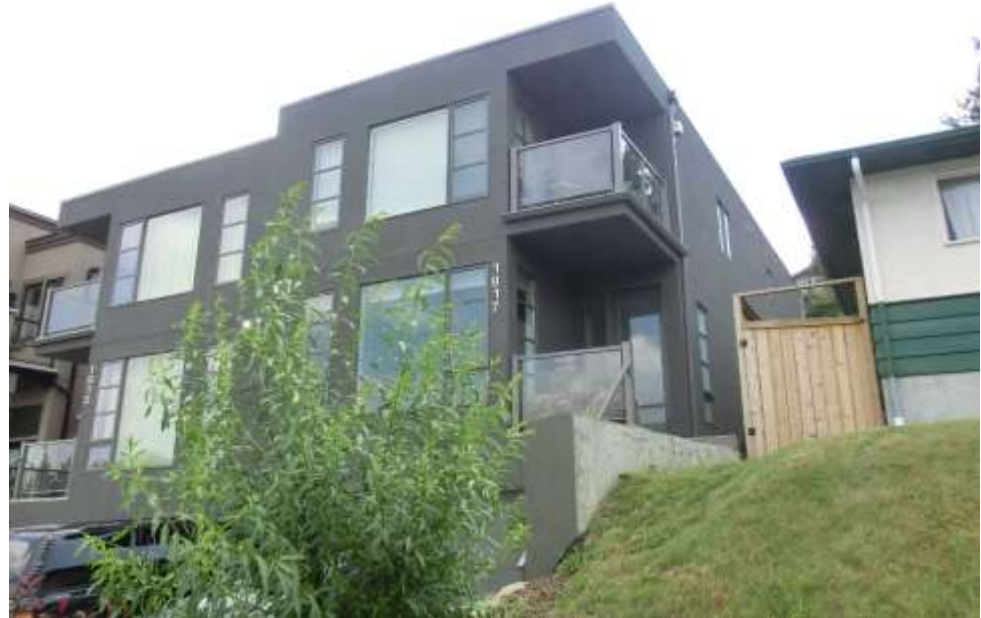
- Typical infill duplex with modern lines, acylic stucco, flat roof
- Water leakage noticed multiple areas on north and west elevations

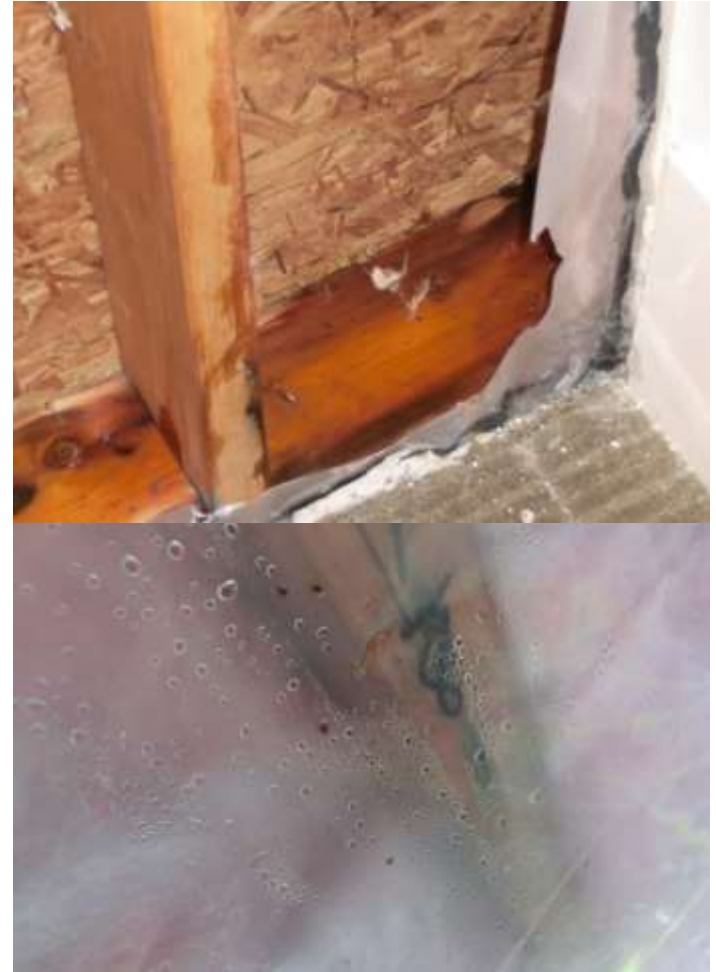
- Exterior wall surface measured at 40°C
- Interior temperature 19°C
- Condensation all over interior poly likely contributing to deterioration
- Extensive damage
- During flood testing water from top parapet, once behind paper, through staples

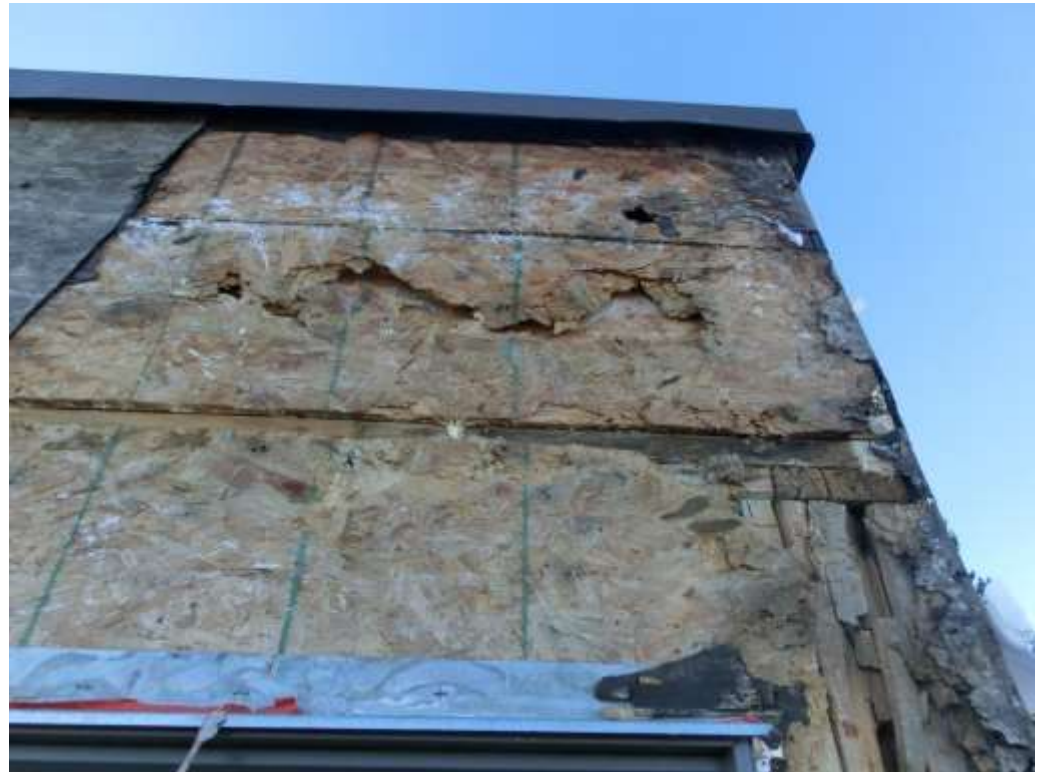
- Continuity of moisture barrier at parapet
- Sequencing
- Common issue

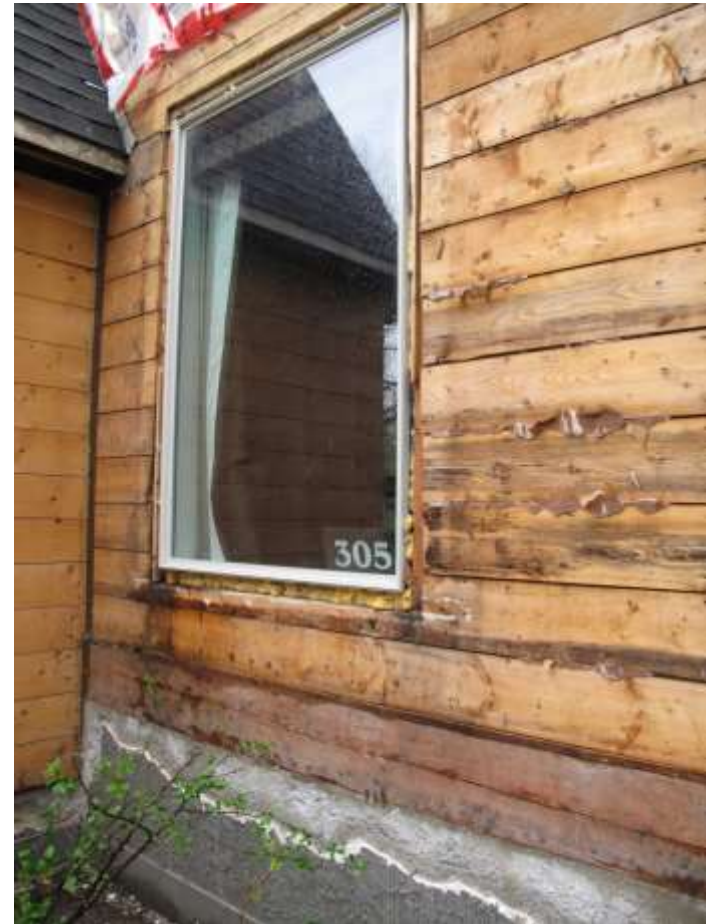
- 1910 house
- Old sheathing in good condition
- Stained was getting wet
- Wanted more insulation-eifs
- How to fastened?
- Choose adhered - CCMC
- Should mechanically fastened or new sheathing

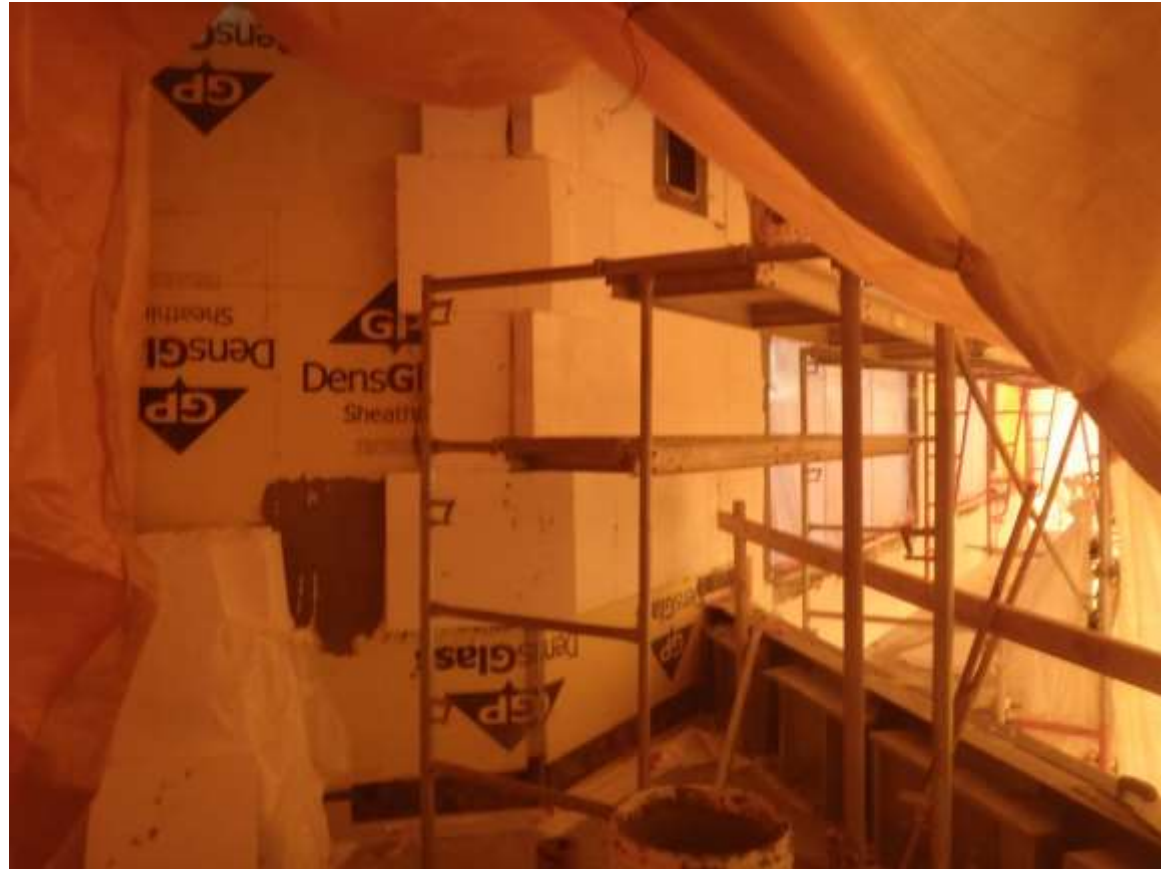
- Moisture barrier and cladding
- All in one = hard for quality control
- Gets covered quickly
- Need qa/qc program
- Take photos
- Request photos

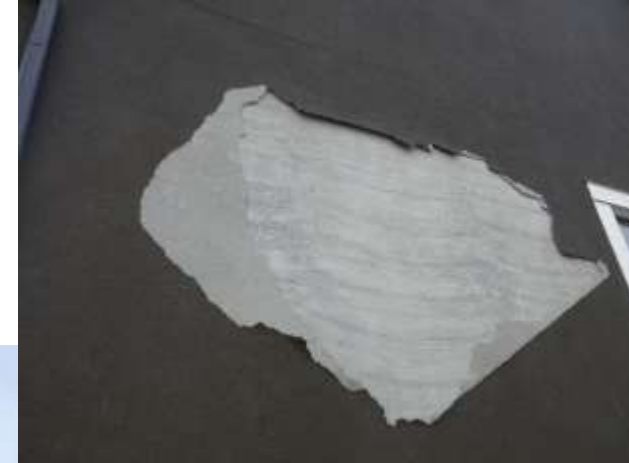
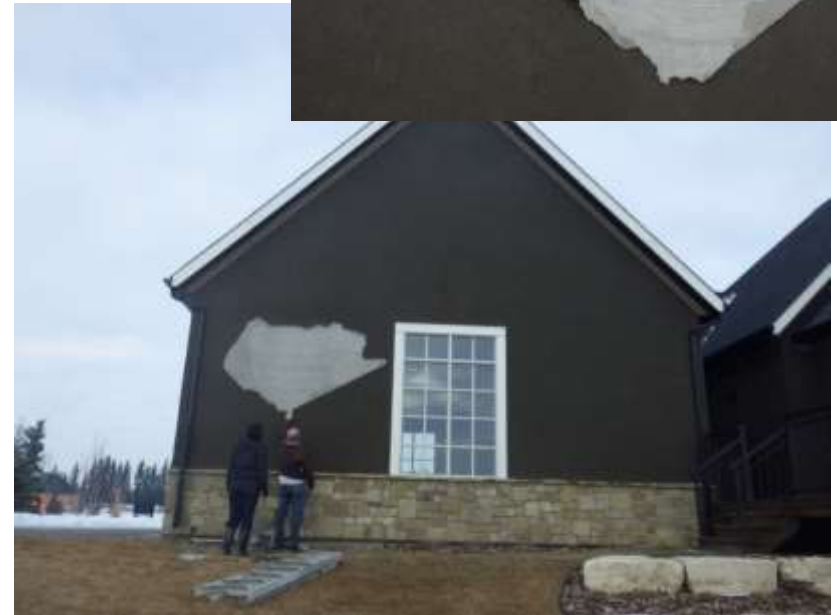
- Stucco and EIFS
 - Temperature and curing requirements
- Different elevations = different temperatures
- 12°C day, -5 at night
- Make sure!
- Redoing = \$\$\$, time, compromised envelope

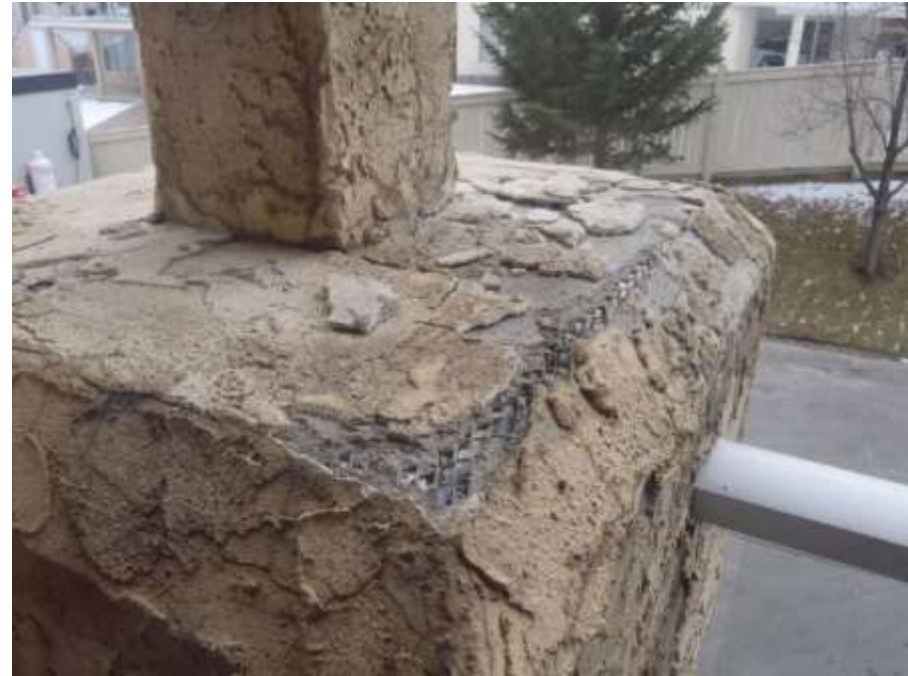
- Stucco and EIFS are not waterproof
- Need proper drainage
- Not designed for horizontal surfaces
- Includes window ledges
- Cover with flashing, waterproof sealer
- Avoid in initial design
- Acrylic, better, but will crack, bubble, peel

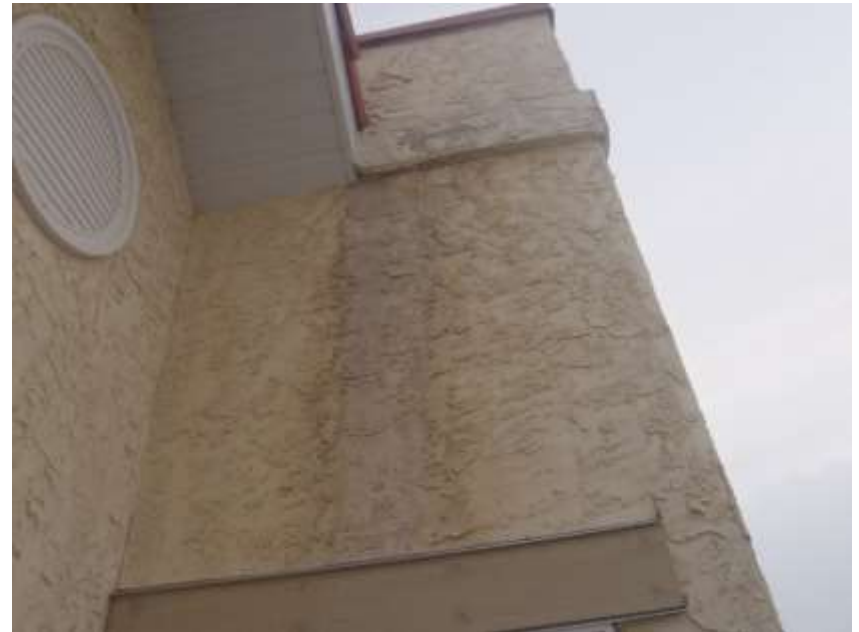
- Stains
- Reduce with good design
- Manage expectations
- Stucco/EIFS WILL stain
- Can clean
- Stains a sign of poorly managed water
 - investigate
- Reduce, can't eliminate

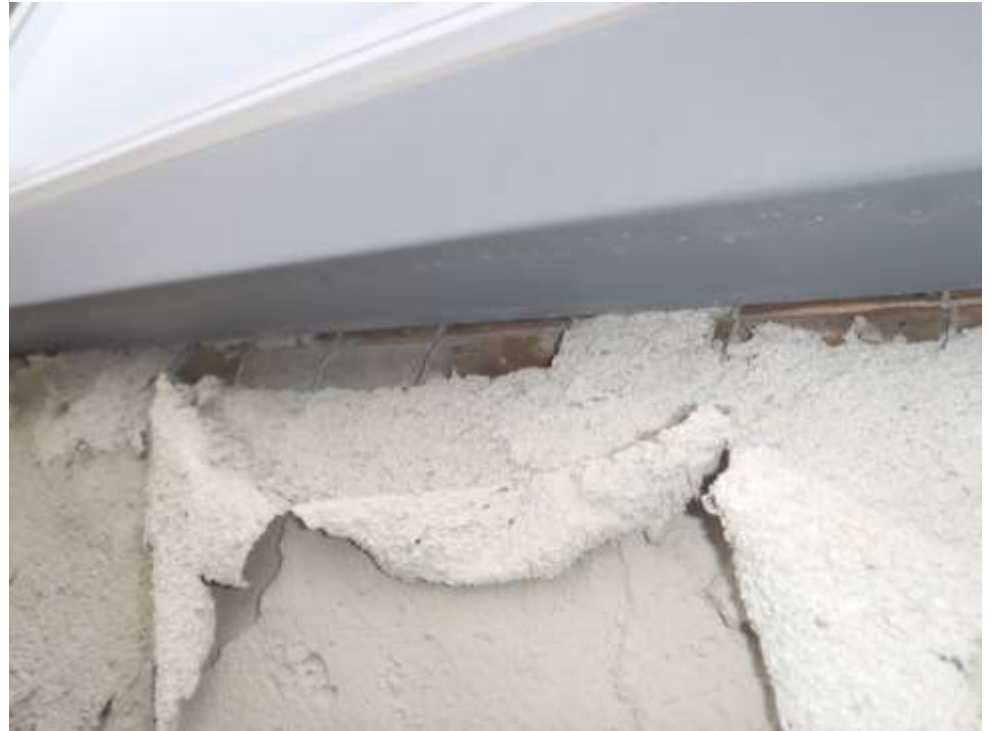
DON'T PAINT!
